SLG46531

ISSUE 1: Counter Incorrect Operation after the Reset Functional Block Affected: Counter

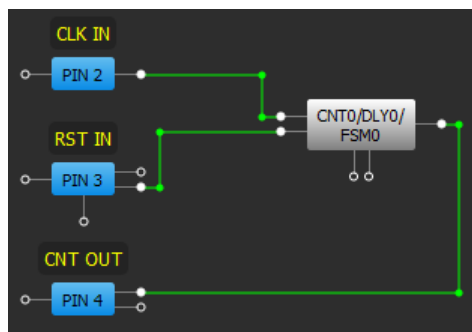
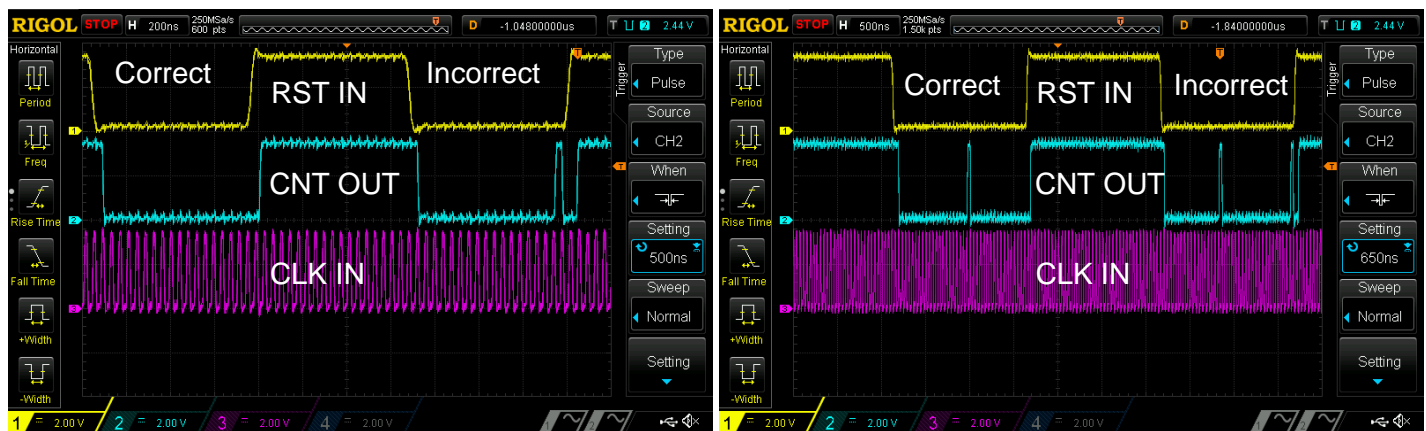
If the Counter Reset is asserted at the same time as a rising clock edge, it is possible that the Counter Data will be reset incorrectly and the counter output may appear faster than expected. This phenomenon appears more often as the clock frequency increases.

- Synchronize RESET input of the Counter with its CLK using 2 DFF cells as shown on picture below.

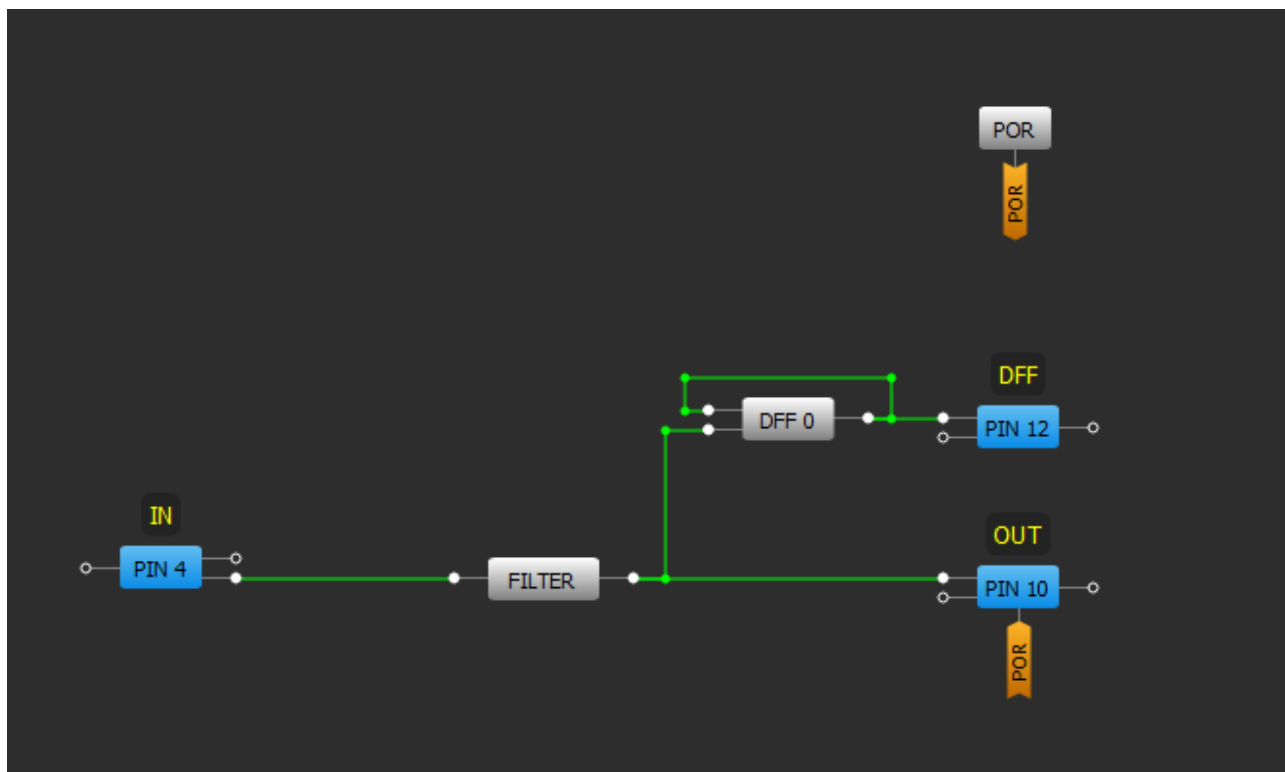
If clock type high frequency input comes in, the FILTER cell may not filter it out. There are several factors like input frequency, duty cycle and LOW duration in such signal that may lead to its passing through FILTER block.

- Channel 1 (yellow/top line) – PIN#4 (IN)
- Channel 2 (light blue/2nd line) – PIN#10 (OUT)
- Channel 3 (magenta /3rd line) – PIN#12 (DFF)

Currently there is no workaround for this issue. Filter block is good at filtering short spontaneous glitches. It is intended to be used in series connection before the delay cell to avoid its latching (see issue #2).

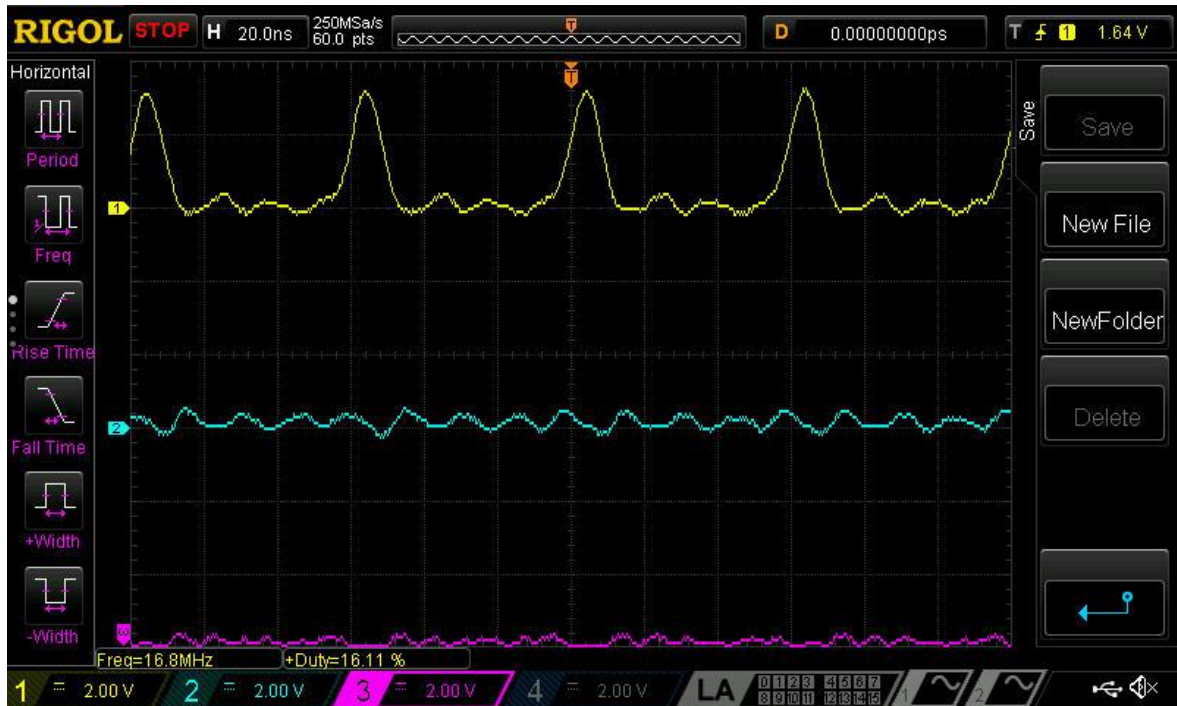
1. Period is 60ns. Pulse width is 10ns DC=16.7% (Correct functionality)

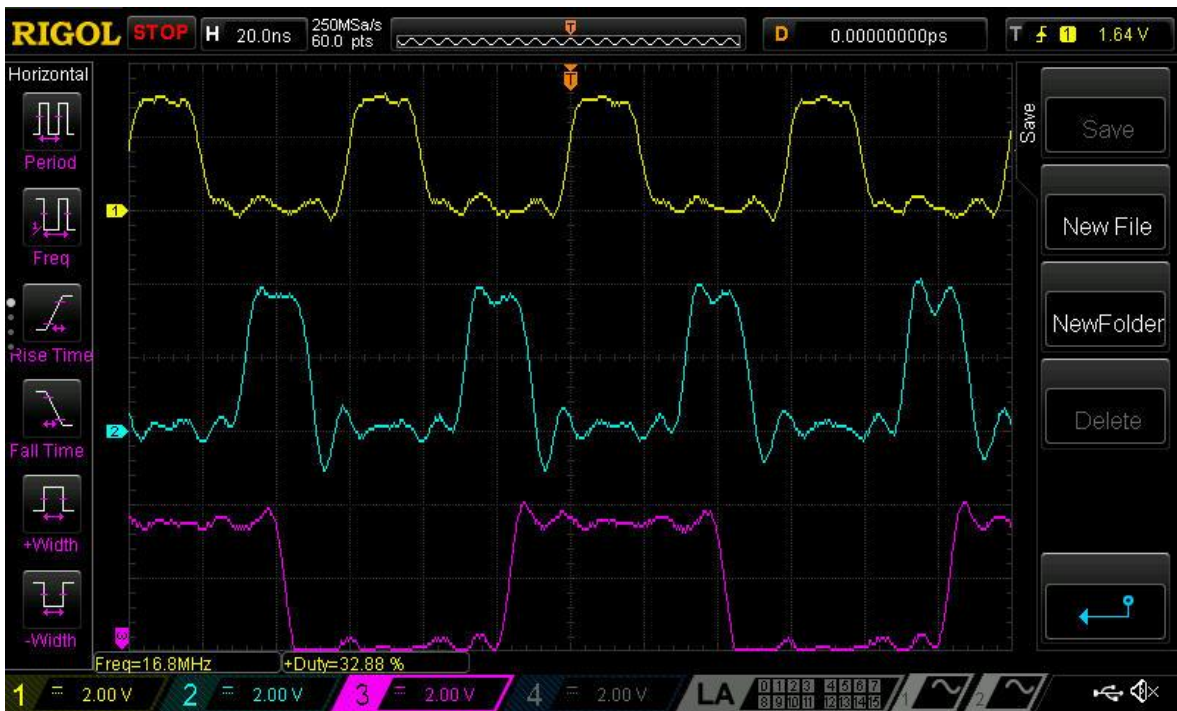
2. Period is 60ns. Pulse width is 20ns DC = 33.3% (Incorrect functionality)

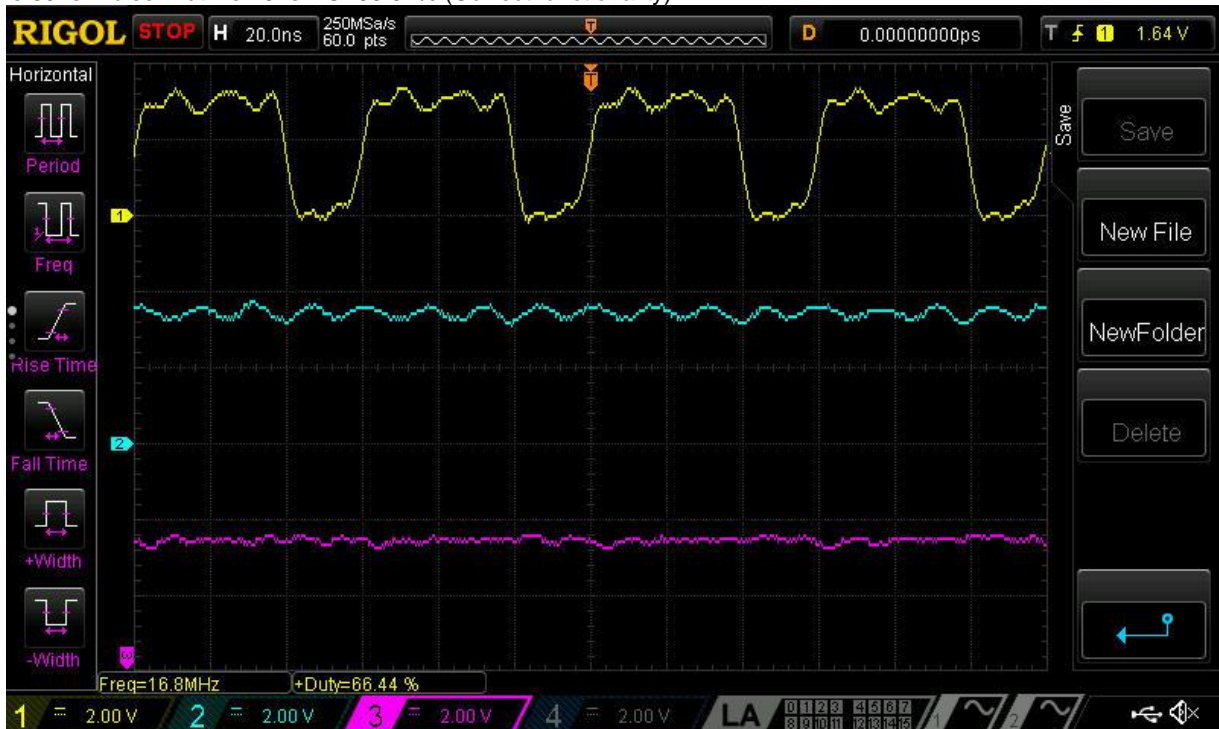
4. Period is 60ns. Pulse width is 40ns DC=66.67% (Correct functionality)

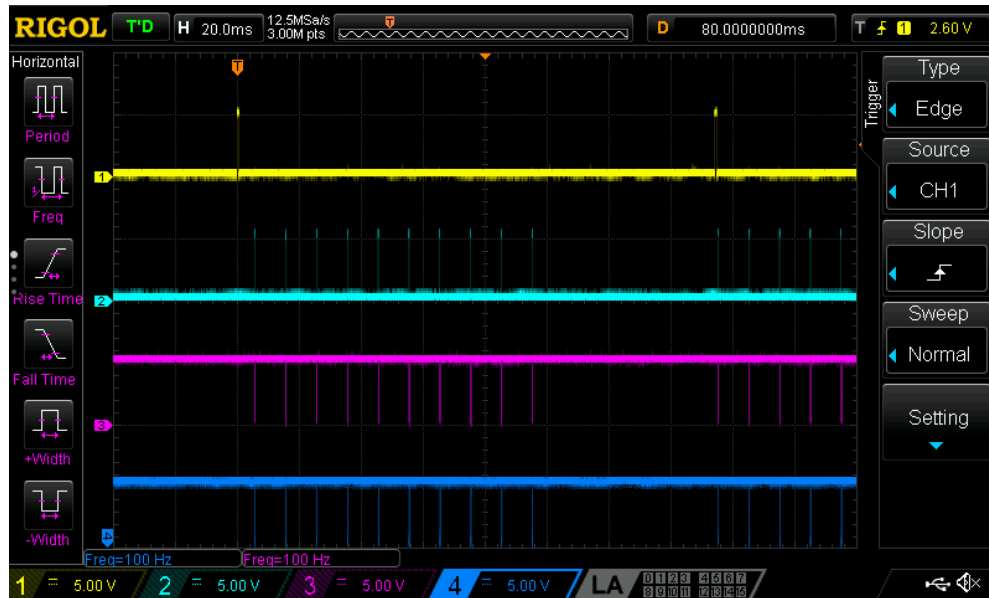
Asynchronous interaction between the CNT/DLY clock input and the I²C latch signal (generated by an I²C read command of the CNT/DLY block's count value) can result in an incorrect I²C data read. The CNT/DLY block will count accurately, but the count value transferred into the block's I²C read register might be loaded incompletely if the I²C latch signal and the clock input occur at about the same time.

The example data capture below shows ten periodic I²C reads of CNT2/DLY2 configured to count down at about 16 clocks per read. The sixth read sample erroneously shows a value greater than that of the fifth. The seventh sample reads as if the previous I²C error never occurred - the difference from the fifth sample (176) to the seventh (143) is 33 clocks or 16 clocks + 17 clocks as expected.

- Channel 1 (yellow/top line) – PIN#2 (CNT2/DLY2 Out)
- Channel 2 (light blue/2nd line) – PIN#1 (I²C Read Triggers)
- Channel 3 (magenta /3rd line) – PIN#8 (I²C SCL)
- Channel 3 (dark blue /4th line) – PIN#9 (I²C SDA)

If the possibility of incorrect I²C data reads can't be accommodated for by external software checks, one can guarantee proper operation by stopping the CNT/DLY block's clock during I²C reads through one of the following methods: by disabling the oscillator block, by reconfiguring the CNT/DLY block's clock source, or by gating an external clock using a LUT (Look-up Table) in the signal matrix. After disabling the CNT/DLY block's clock, the count registers can be read without error. Please note that this workaround will add the I²C read and processing time to the counter's overall clock period.

The best workaround depends on the resource constraints of the application. If the oscillator block doesn't clock other logic elements within the design, a matrix output can be used to manually power down the oscillators for the I²C read. When the CNT/DLY block's clock source is routed internally from the oscillator block, I²C commands can temporarily reconfigure the CNT/DLY block's clock source registers to select "Ext. CLK. (From Matrix)." This action will disable the clock by connecting it to ground. If the CNT/DLY block is clocked from the signal matrix, a LUT can be used to gate the clock during an I²C read.
